“Anti-Skid Service Required” problem caused me headache when I bought 2009 Volvo XC90 at 2015. Sometime have problem, sometime not, sometimes have “brake failure stop safely” happened.

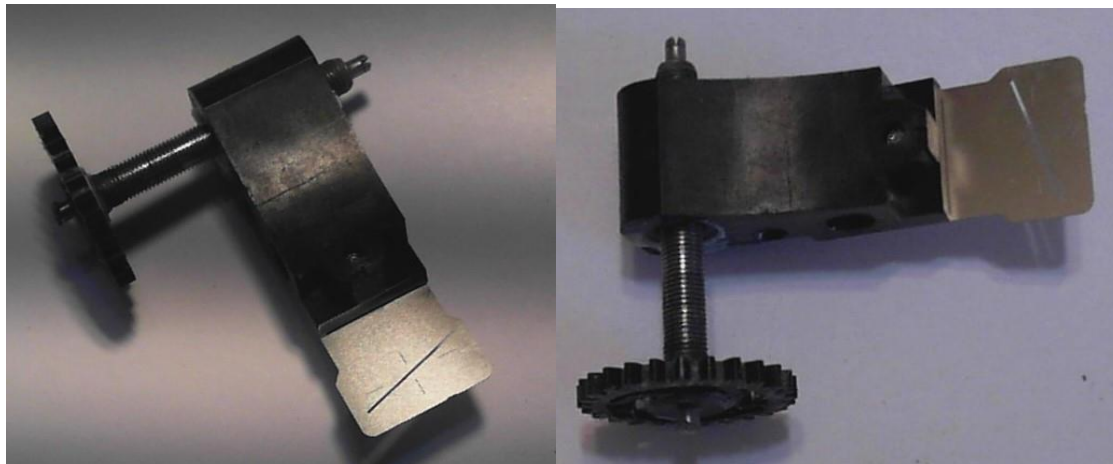
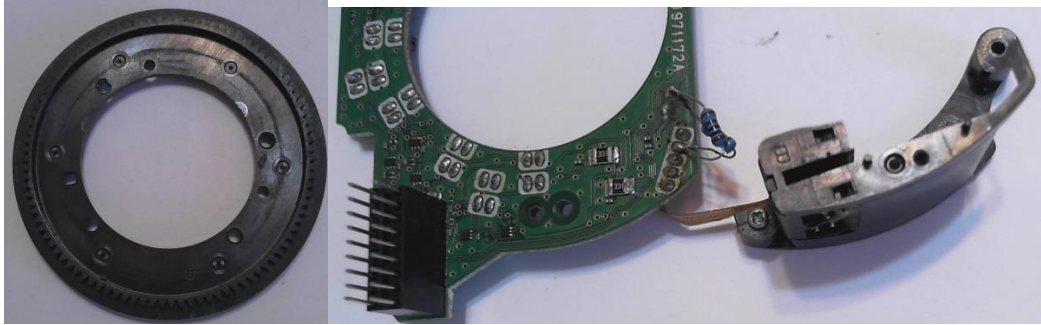
At 2016, I bought Volvo diagnostic tools and try to resolve this problem. Most of direction led me to check Steering angle Sensor, So, I opened Steering angle Sensor and cleaned Grating and Transmitter and receiver. Problem still same especially at winter time, it became worse.

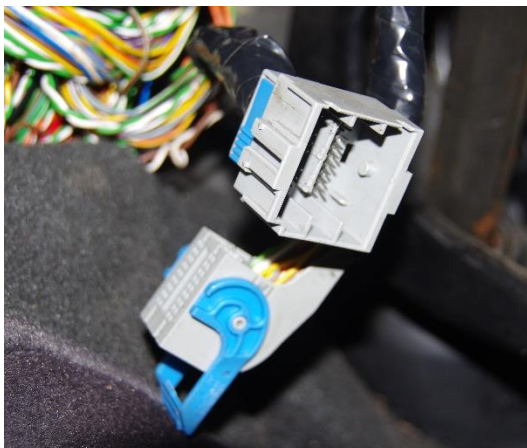
Till to 2018, when I touched 36 pin connectors (54/3.1:1-36) wires, “Anti-Skid Service Required” happened. So, I knew problem happened in here. But there are too many wires need to solder, and also, it is tuff for further repair if need disconnect this connector.

On 2019 winter time, car have “brake failure stop safely” issue and can’t change gear during long distance driving. I have to go to Volvo dealer, they just cleaned error. So, money spent while problem still kept.

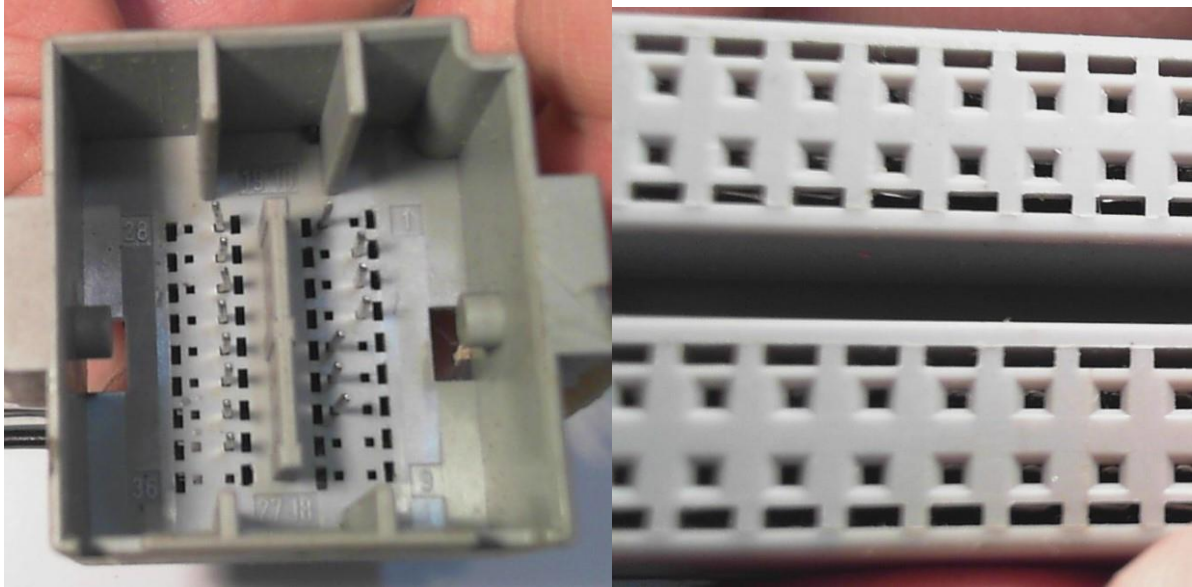
### 54/3.1:18-36

At May2021, I thought I need to sale this car and I don’t want kick this ball to buyer. So, I decided to fix it. I searched wire diagram of XC90, found there are just 7 wires need to solder them together. There are terminal 5,6,7,8, 11,12,18. I decided to duplicate them since there are sufficient blank terminals.

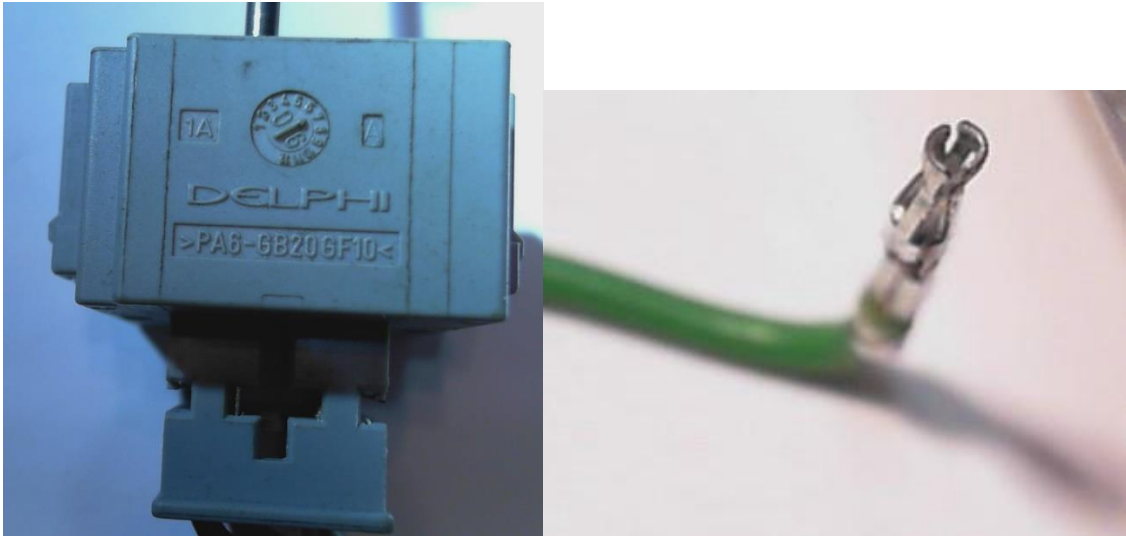
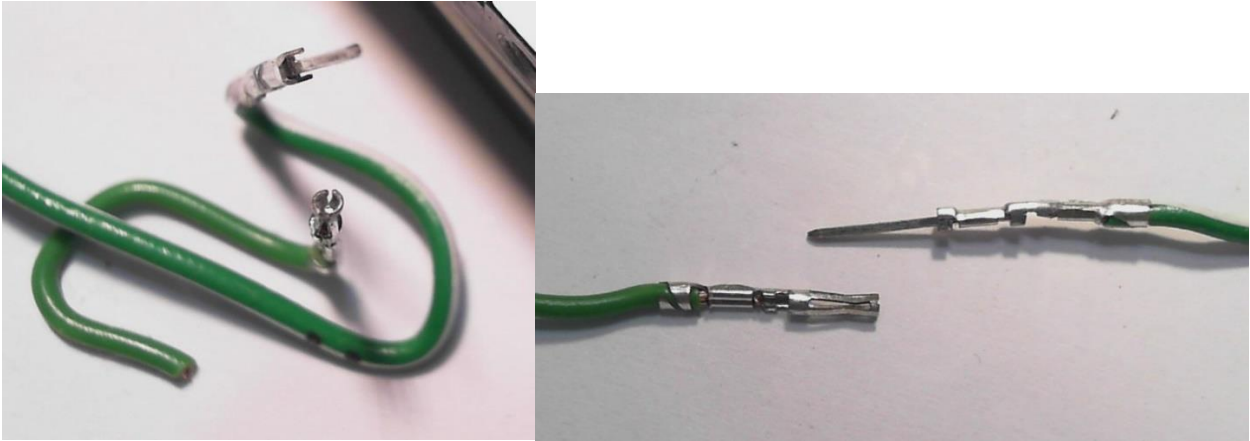
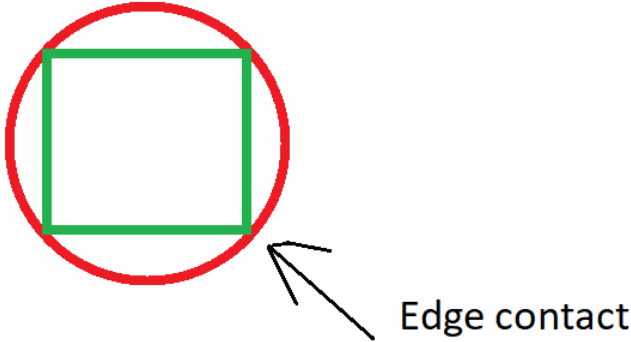
Till right now, there are no problem any more. So, Problem is this connector! And this connector come from my previous company!

Since I worked at DELPHI technical center, served as Mechanical Engineer before. For this connector issue, I suppose it should be never happened if Mechanical Engineer and

- 1, If there are some wires are very critical and have high risk cause failure that customer dissatisfied such as brake failure, need consider duplicate them.
- 2, Male terminal section is square shape and Female terminal is circle. If connect them together, there will be edge contact or point contact. This kind of contact can't be used for high current and has reliability issues since edge will be oxidized. So, it is better to consider how to make round male terminal to form surface contact. I suppose it is not difficult for manufacturing Engineer.
- 3, I have no way to determine what kind of material and coating used for Female terminal, Maybe it is SUS with Sn coating. I suppose it is better use Beryllium copper with golden coating since it has good Elastic deformation and good conductivity.
