VOLVO S60/V70

(2000-2004)

center console cup-holder lid hinge fixing process

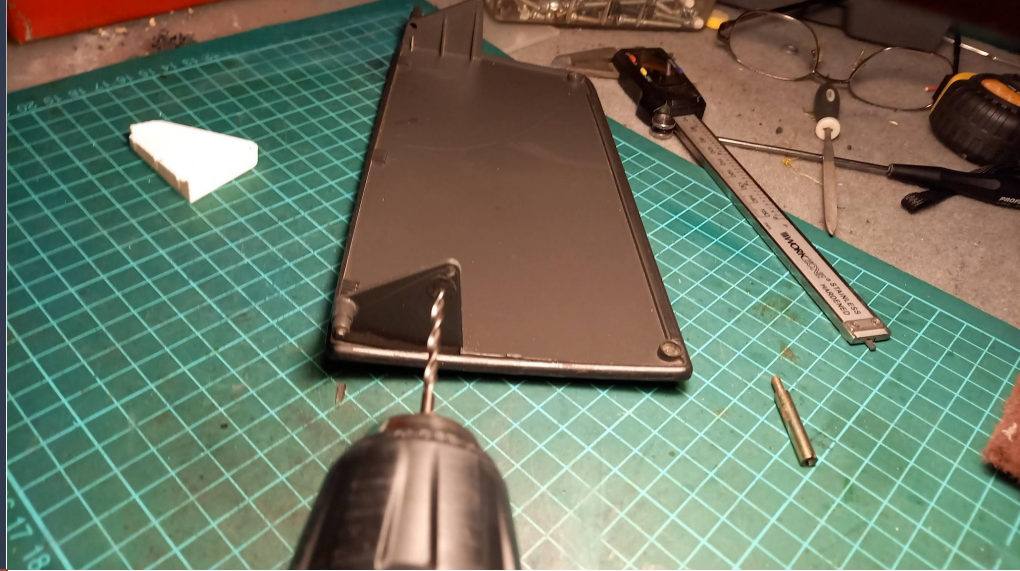
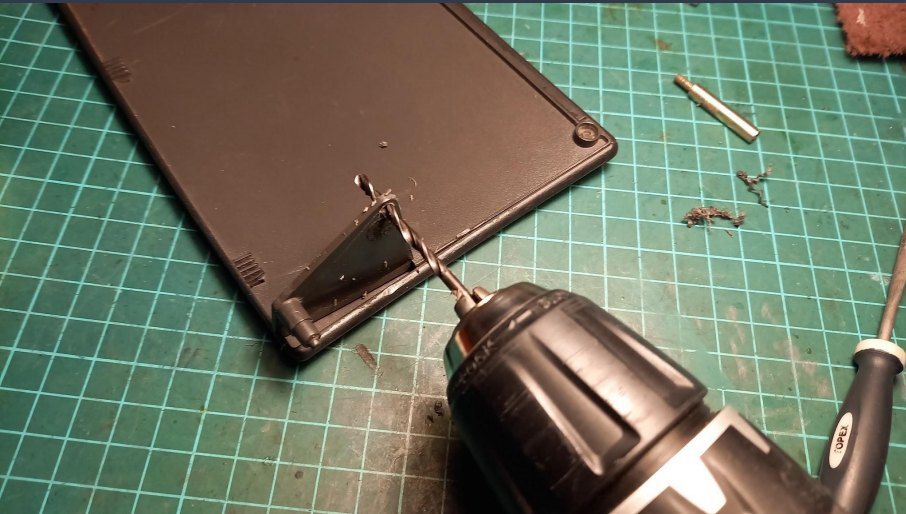
Remove the center console from the car.
Take it apart.
The original plastic hinges were broke off.
The longer one (left on the picture) has
been glued back with superglue.
The other one is drilled thru D=3mm

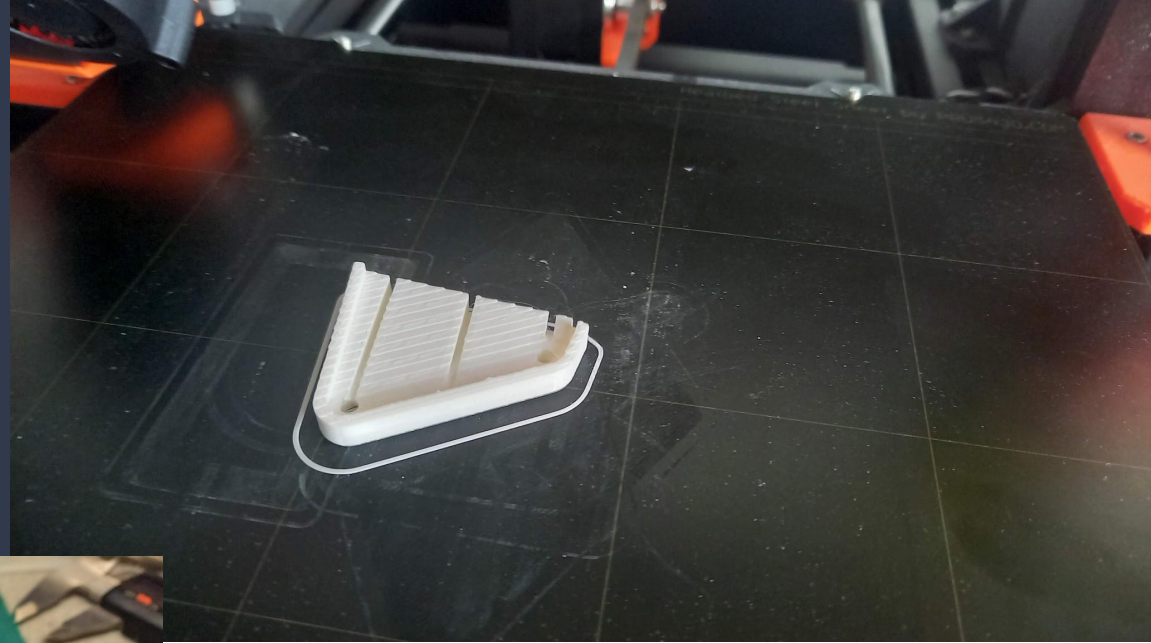
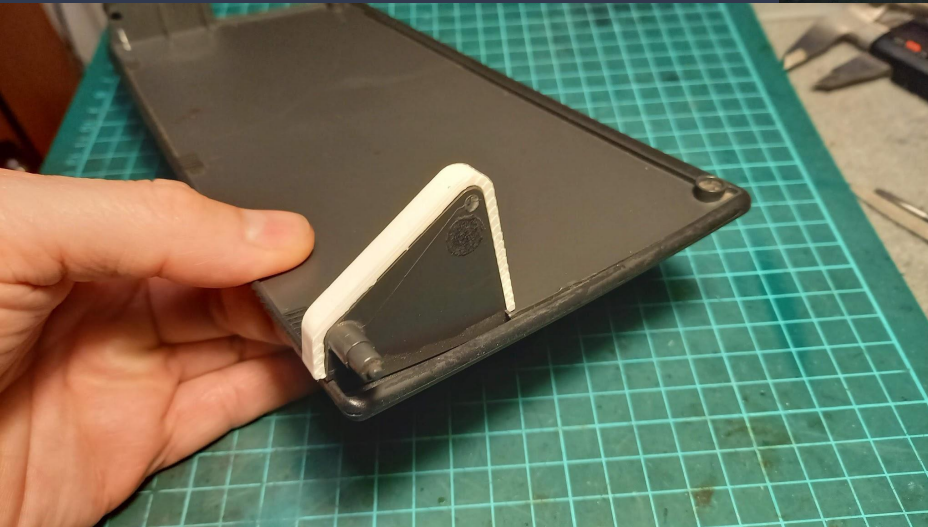
I designed and printed out the two pieces of hinge reinforcement. Left and right are different by size (and mirrored). The white part on the picture is initial test version. For the final I printed it black. The test fit is OK.

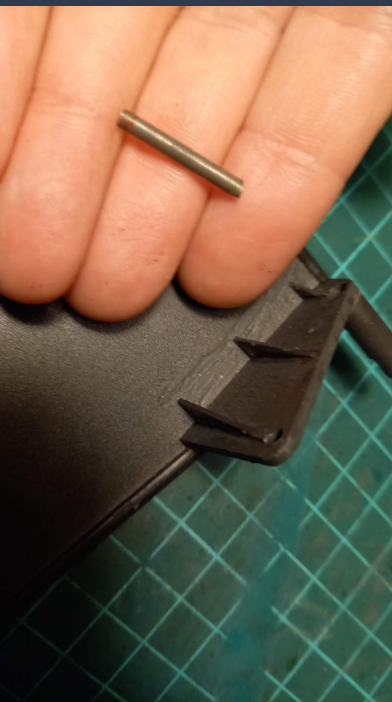
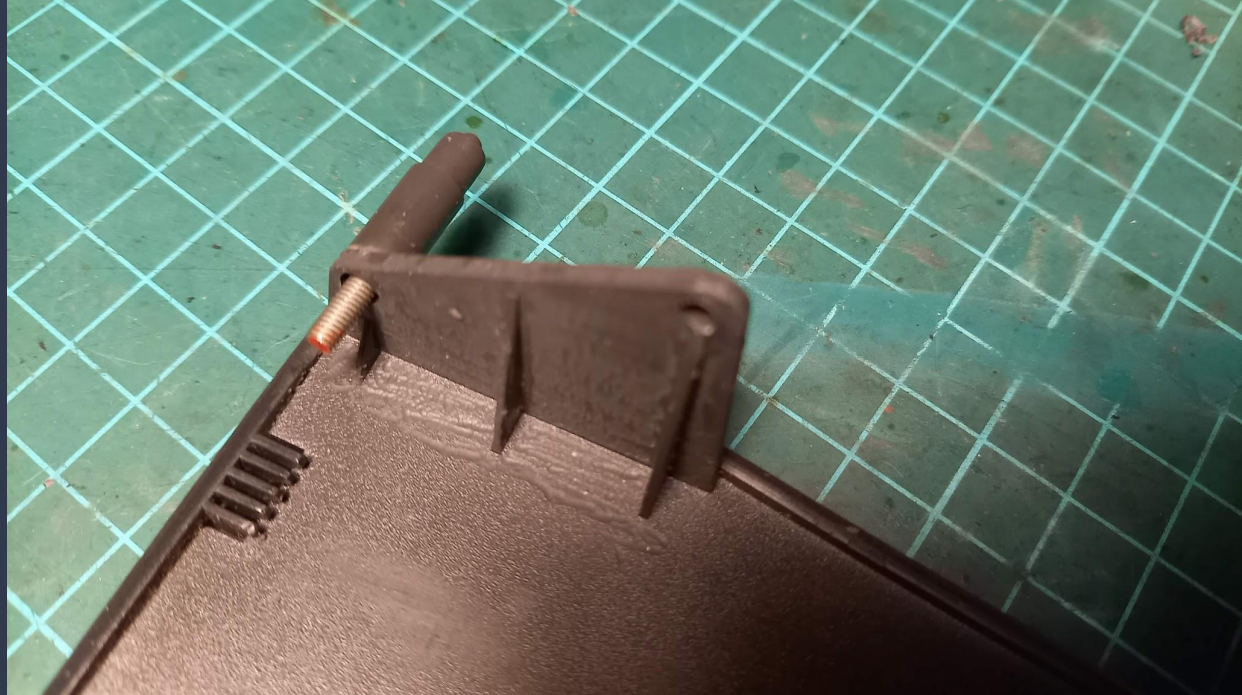
Cut a reinforcement piece for the hinge from M3 bolt. 13mm and 19mm is sufficient. Left and right is different.
Finally it will be glued into hole.

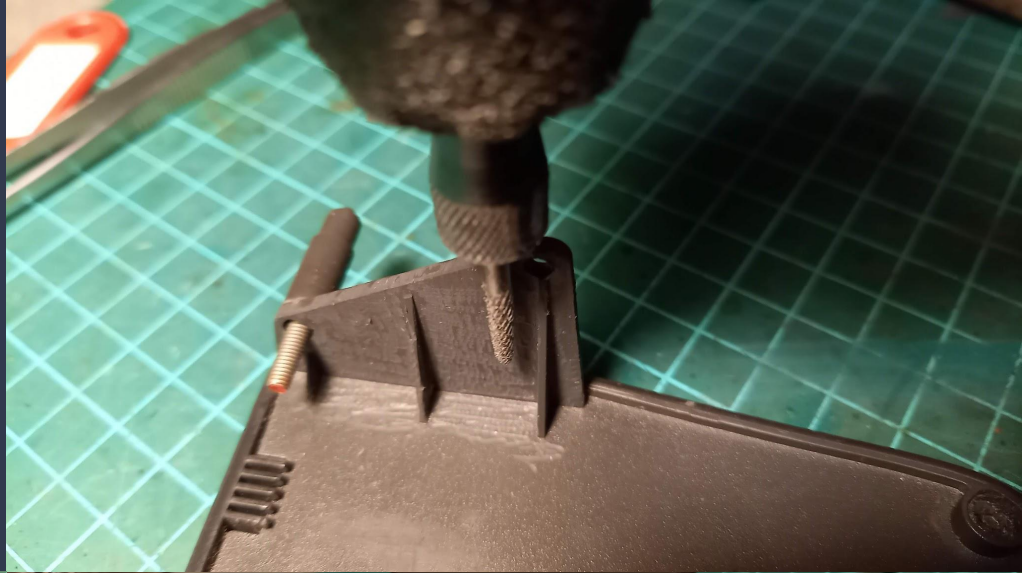
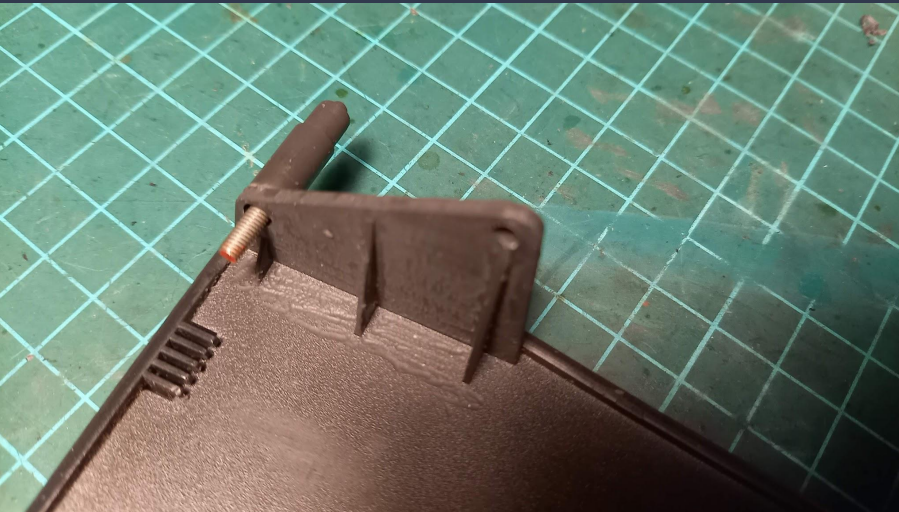
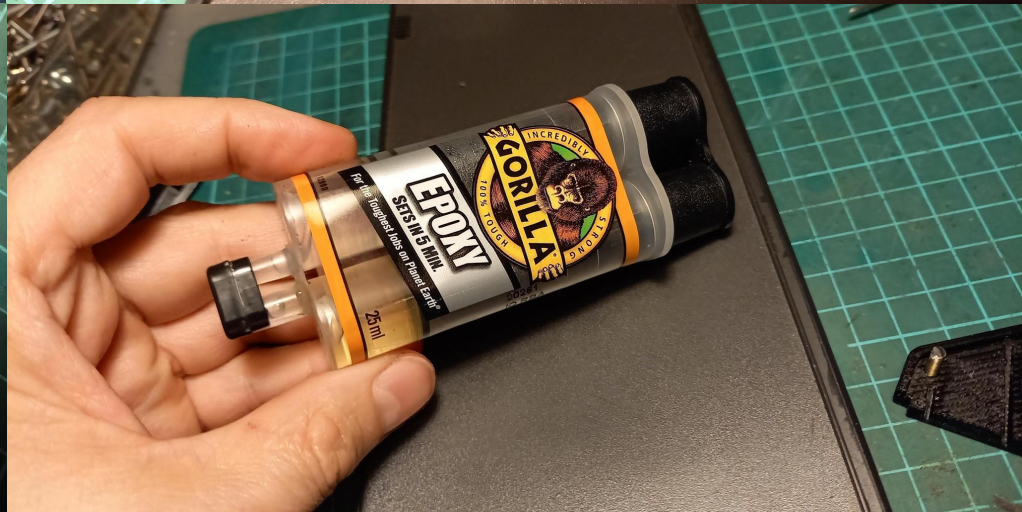
Then I made the surface rough for efficient sticking of glue.
The glue I suggest is a two compound epoxy resin based glue.

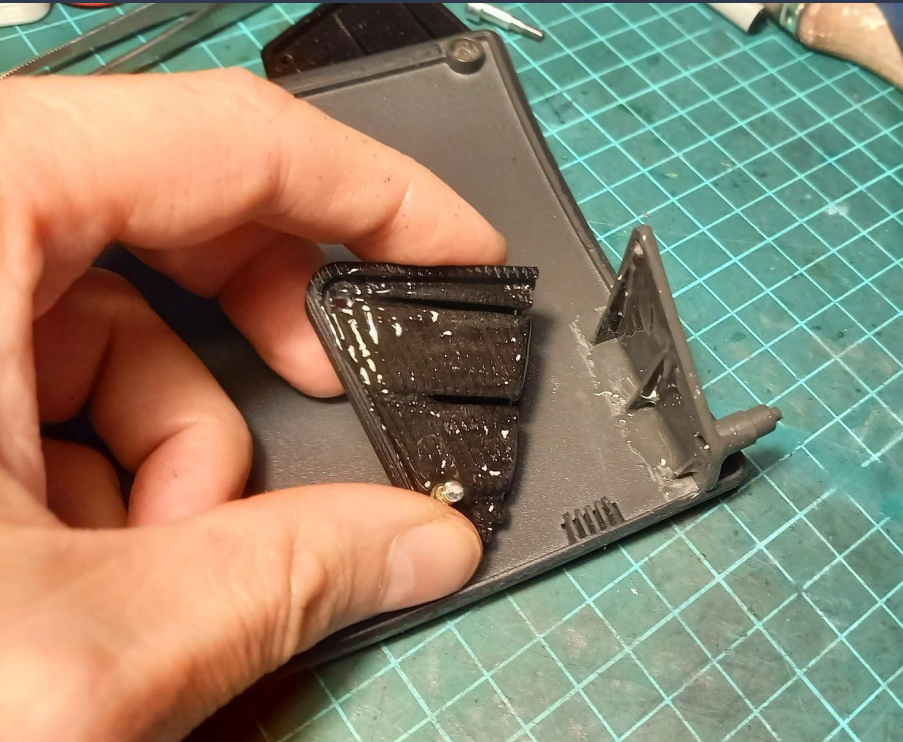
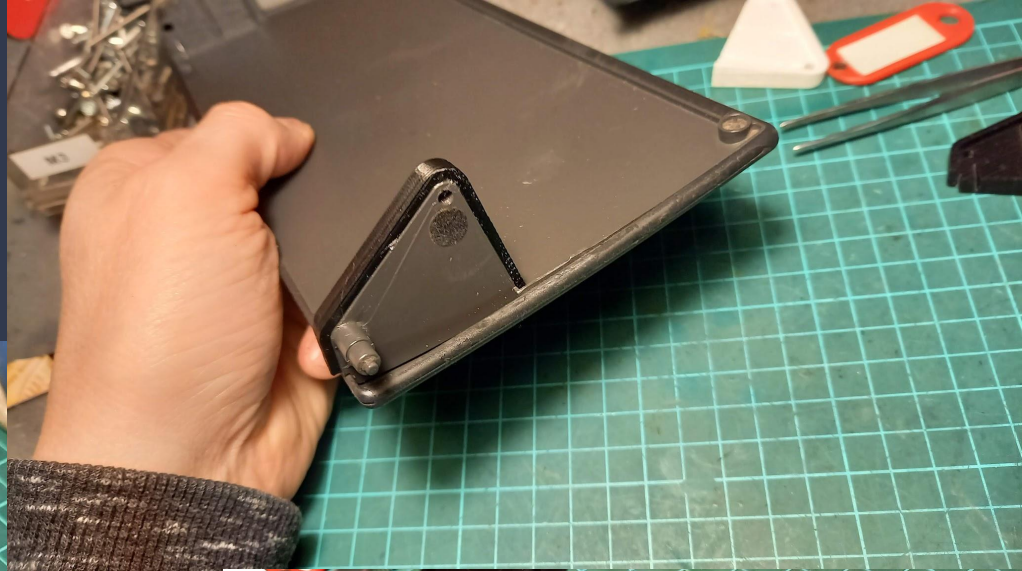
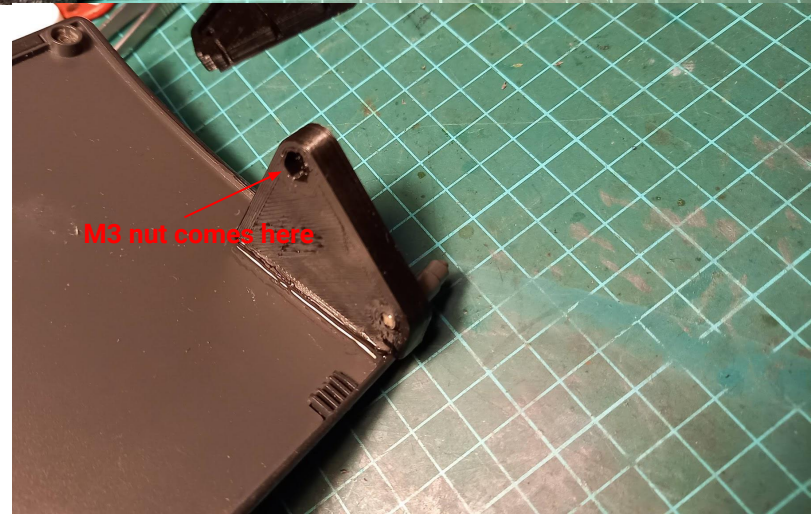
Add glue to the contact surfaces. Both side.
As well as to the stud bolt. Insert the
prepared M3 stud into printed part.
Position the hinge extension to final state.
An M3 nut will be inserted into hex slot.
(sorry missing from the picture)

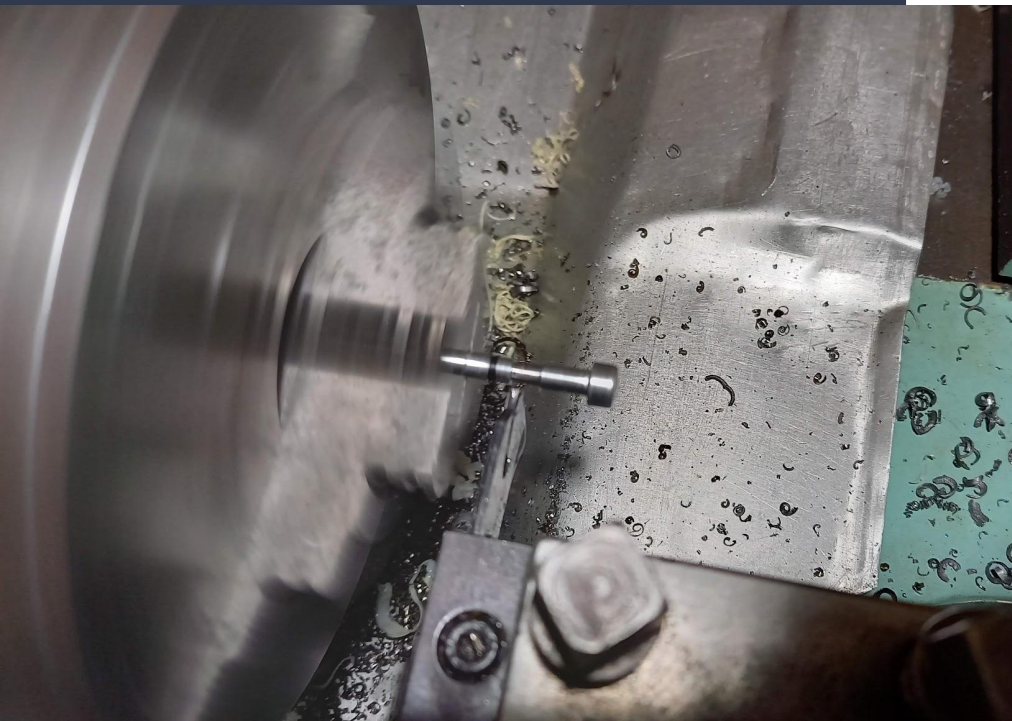
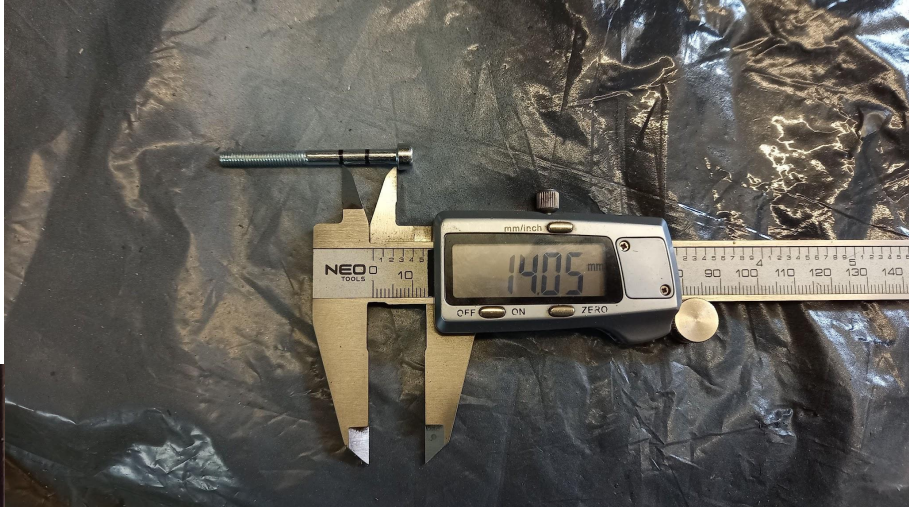
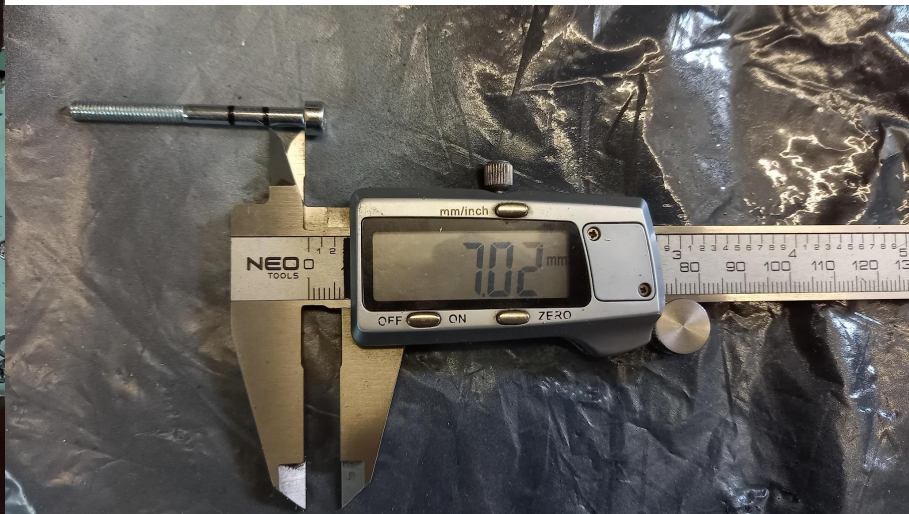
Two new shafts need to be manufactured.
Raw material is an M4 hex socket screw
partially threaded.
Final total length is 14mm. The d3 step is
6,5-7mm long.

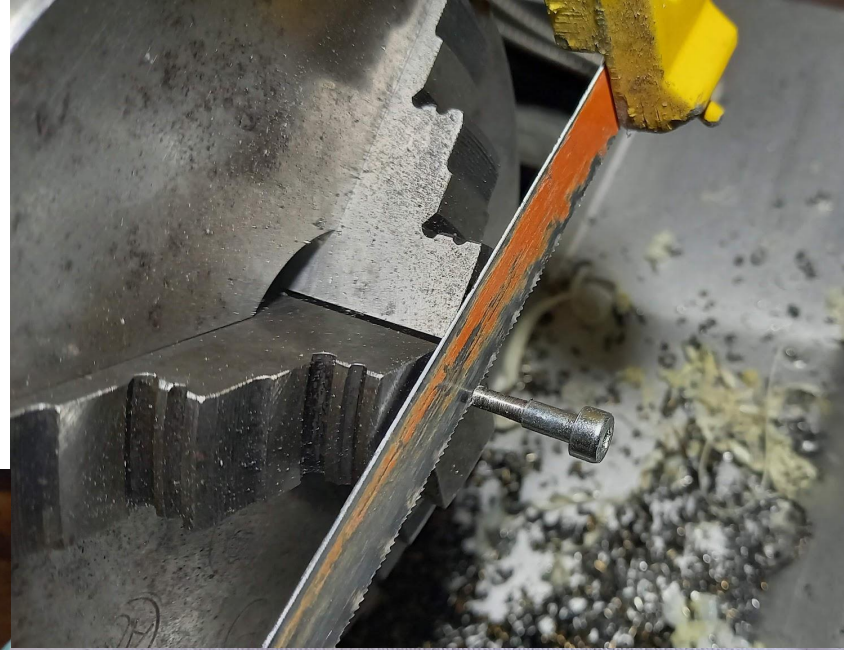
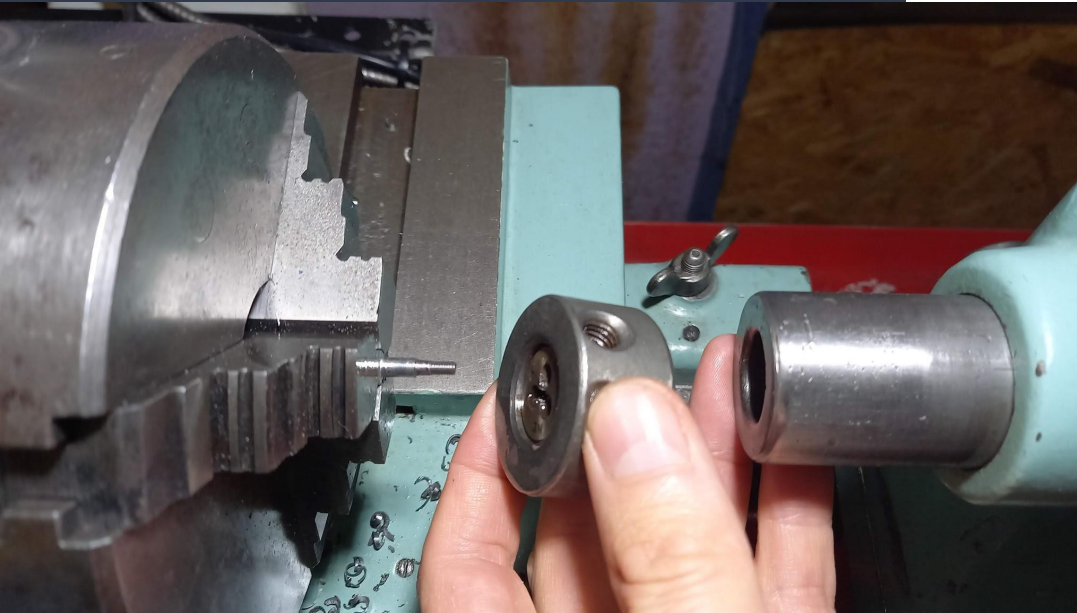
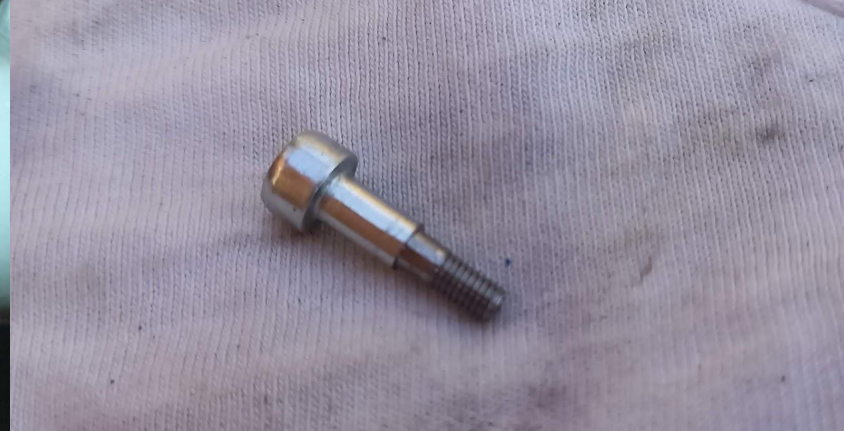
Follow the pictures and use Your imagination how to make the mini shaft, depending on Your machining possibilities.
The final result is a pin bolt with 4mm neck and M3 thread on tip.

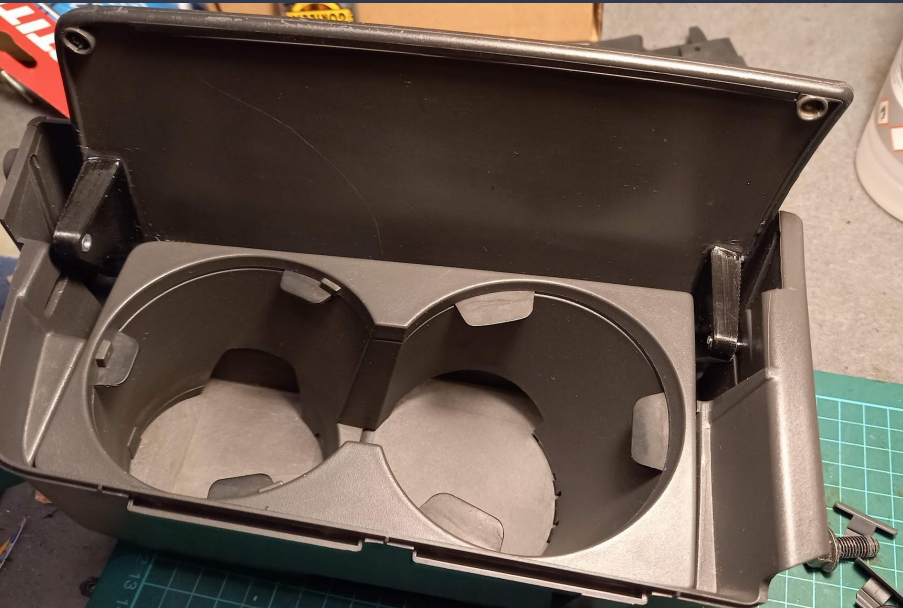
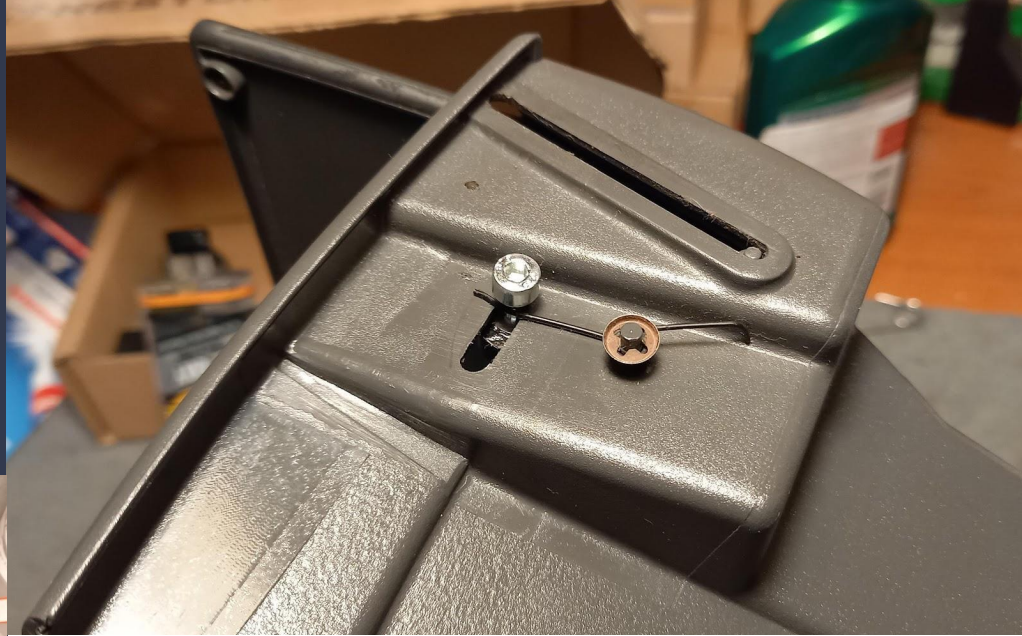
Once the glue has cured, it is time to mount the lid back to it's place.
The new shaft bolt is installed from outside, as shown. I used thread locker to make sure it stays.

The refurbished lid is back in service.
