How to Remove a Tail Light on a 2019 Volvo XC60 T5 Momentum

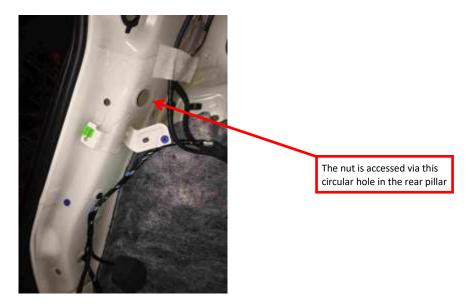
33. Locate the nut holding the top of the tail light assembly in place. The nut is located near the top of the tail light assembly and is accessed via a circular hole in the rear pillar.

34. The nut is screwed onto a threaded stud that sticks out of the rear of the tail light assembly. Make sure you use a magnetic socket to remove the nut. As I discovered too late, unless a magnetic socket is used, it is pretty much a certainty that the nut will be dropped down inside the pillar during removal. A minimum 125 mm long extension bar will be needed to be able to reach the nut with the socket. The existing nut is an M5 threaded black zinc coated flange nut (i.e. a sems nut). The Volvo part number for a replacement nut is 30640699. However, any M5 zinc coated flange nut will be OK to use if you lose the original. If you do drop the nut down inside the pillar then you may be able to fish it back out (as I was able to) with a flexible magnetic pick-up wand. The threaded stud that the nut screws onto has a 5 mm long unthreaded section at its end that will push against the inside base of most magnetic sockets (which usually aren't as deep as a standard socket) and prevent the magnetic socket from engaging with the nut. To get around this you will need to use a standard 8 mm socket to make the first few turns when undoing the nut and then swap over to a magnetic socket for completing the rest of the nut removal. Remove the nut using an 8 mm magnetic socket.

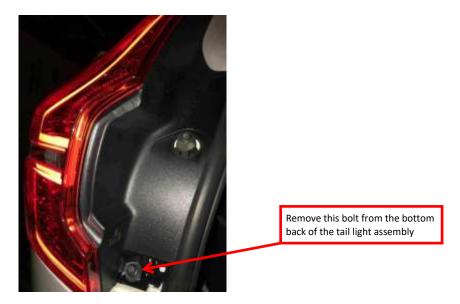
35. Locate the bolt holding the bottom back of the tail light assembly in place. Remove the bolt using an 8 mm socket.

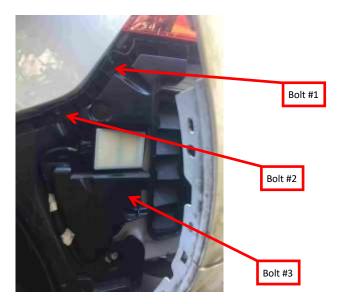
36. Loosen the black plastic impact absorber that sits below the tail light assembly and behind the wheel arch. It is held in place by 3 bolts. Remove the three bolts using an 8 mm socket.

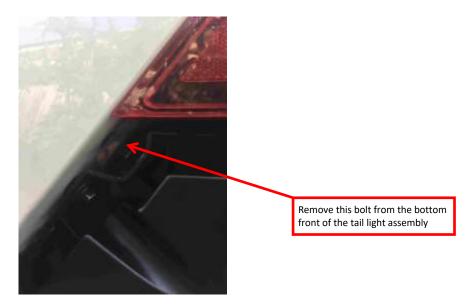
37. Locate the bolt holding the bottom front of the tail light assembly in place. The bolt is located near the wheel arch immediately below the tail light assembly. Remove the bolt using an 8 mm socket.

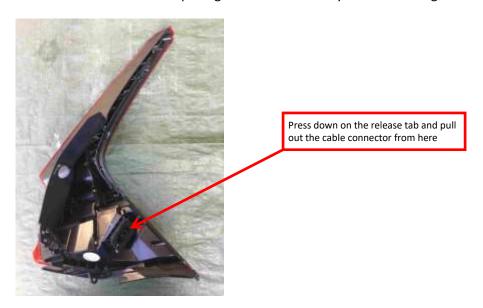
38. Partially pull out the tail light assembly and undo the electrical cable connector by pressing down on the release tab and pulling the connector away from the tail light assembly.
