Your satisfaction with your Volvo and the Volvo organization is very important to us. We are committed to ongoing product improvements; therefore, we have launched Active Service Campaign A10140 Antenna Cover.

Volvo Car USA LLC, on behalf of Volvo Car Corporation, has decided to launch Active Service Campaign A10140 on certain Model Year 2021 and 2022 90 Series, XC60 and XC40 vehicles with Google built-in.

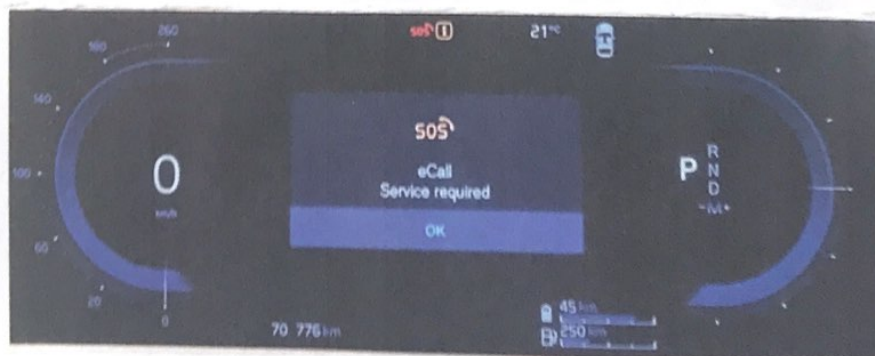
Volvo Cars quality investigations have identified that there's a risk of a gap between the car body and the antenna cover. This may lead to noise and water intrusion and if not addressed there may be a risk that water damages the TCAM which over time could potentially, in rare cases, result in loss of connectivity and a message in DIM.

Your authorized Volvo retailer will inspect the gap between the antenna cover and car body. If necessary, Volvo Cars will refit the antenna cover.

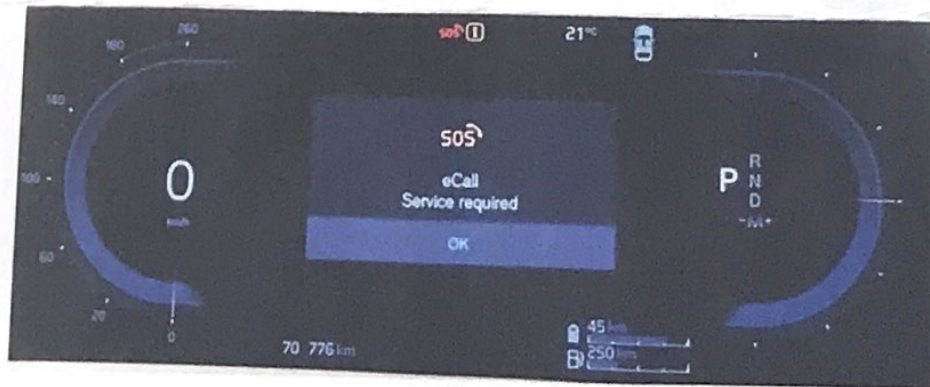
Volvo Cars quality investigations have identified that there's a risk of a gap between the car body and the antenna cover. This may lead to noise and water intrusion and if not addressed there may be a risk that water damages the TCAM which over time could potentially, in rare cases, result in loss of connectivity and a message in DIM.

Your authorized Volvo retailer will inspect the gap between the antenna cover and car body. If necessary, Volvo Cars will refit the antenna cover.
